Anderson-Nichols

June 29, 1979

SUBJECT: Inspection of 18 Lower Connecticut River, N.H. Dams
Contract No. DACW33-79-C-0009
Our Job Nos. 3220-03 and -04

Mud Pond Dam - Line Item 04 - This dam, at about elevation 1050 feet msl, was originally a wooden frame and decking dam, built about 1899 and in 1907 an additional 2 feet in height was added to provide more storage. This occurred when the dam was converted from a water power source for a peg mill and/or fulling mill to a small hydroelectric generating plant about $\frac{1}{4}$ mile and 85 feet below the dam. The present concrete gravity dam was built in 1917. The dam is located on Stanley Brook, in the Town of Dublin, that originates from Thorndike Pond in Jeffery. Stanley Brook joins Brush Brook about $\frac{1}{2}$ mile downstream of Mud Pond Dam and Brush Brook flows into Edward McDowell Reservoir about $\frac{3}{4}$ mile below the confluence with Stanley Brook. Mr. Mitchel Wenigmann, Main Street, Dublin, N. H. 03444, is the present owner.

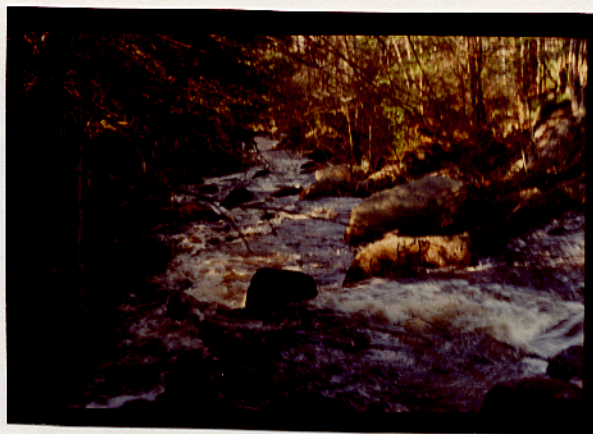
Downstream Channel

The dam is in fair condition. Noticeable seepage was issuing from a joint or crack on the left (west) side near the top 1 or 2 feet of the dam. Other areas of seepage were noted on the downstream face near the toe in addition to the leakage from the penstock. Some cracks were observed in the concrete as well as some spalling of concrete. The downstream channel is steep, rocky and the banks contain trees and brush.

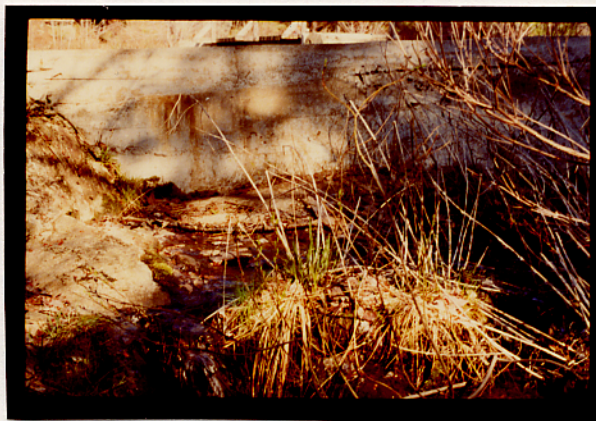
Seepage from Left Training
Wall

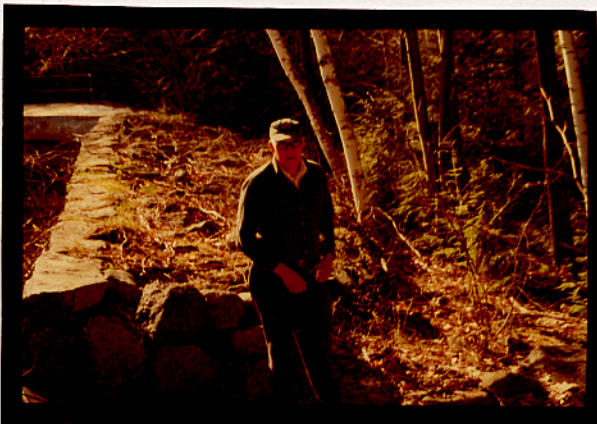
Emergency Spillway (Rock
and Soil Dumped Just to
Left of Photo Toward
Reservoir)

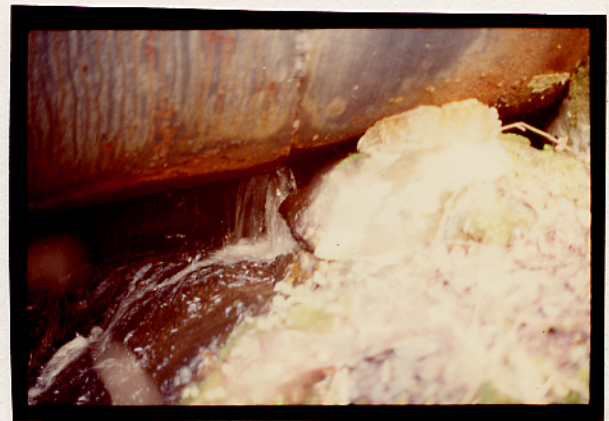
Leakage from Penstock
